REPORT NO. SP-665  
DATE 5-14-64  
COPY NO. # 6

**MODEL** A-12

**TITLE** LIGHTNING TESTS - MODEL A-12 PLASTIC RUDDER

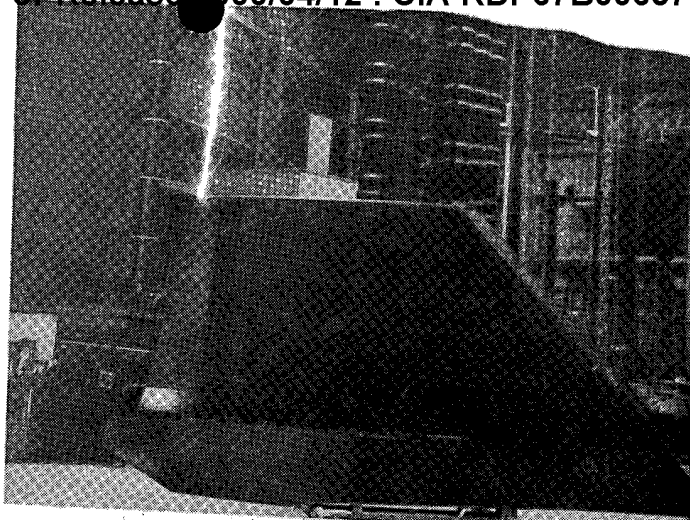
Photo VI-1. Run VI  
Small Piece of Rescon  
on T.E. corner. Rudder  
deflected.

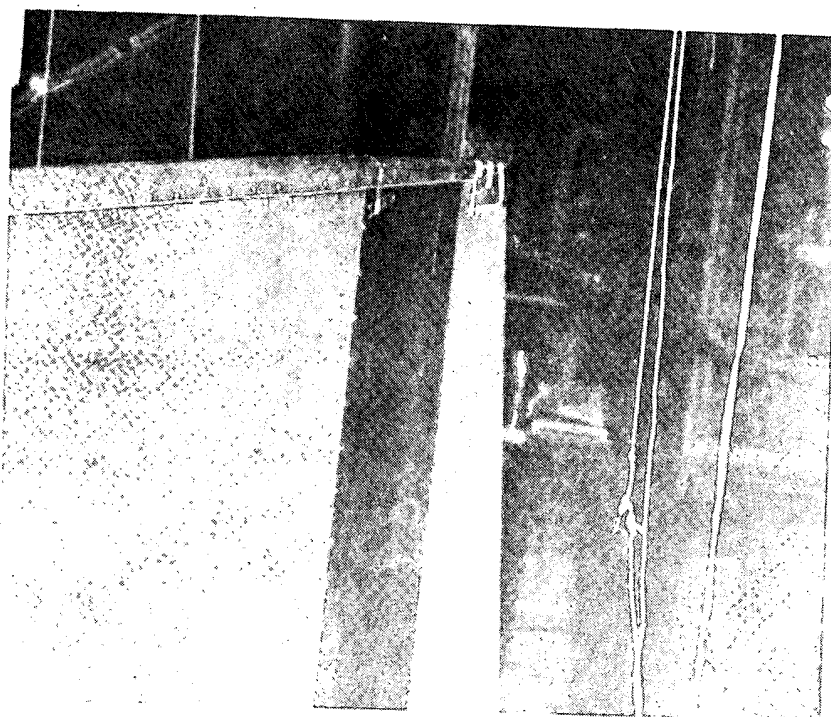
Photo VIII-5. Aluminum Foil on T.E. Rudder Tip as Tried in Run No. VIII.

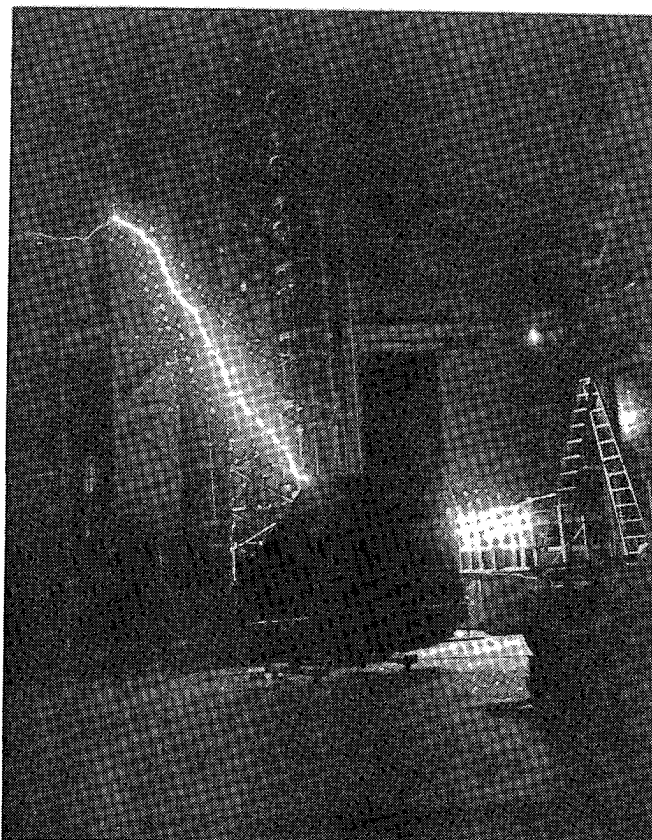
Photo XI-1. Run XI. Aluminum Caps on  
and short copper lead from Run X retained.  
Forward electrode location.

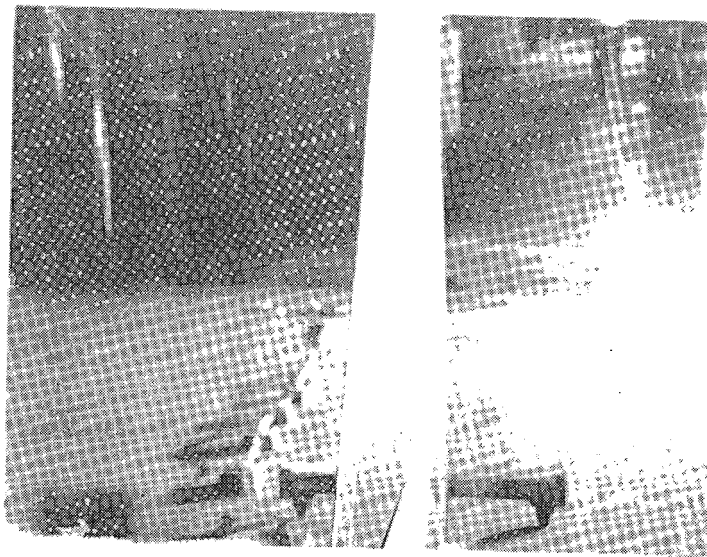
Photo XIV-1. Run XIV.  
Copper dipoles  
installed.

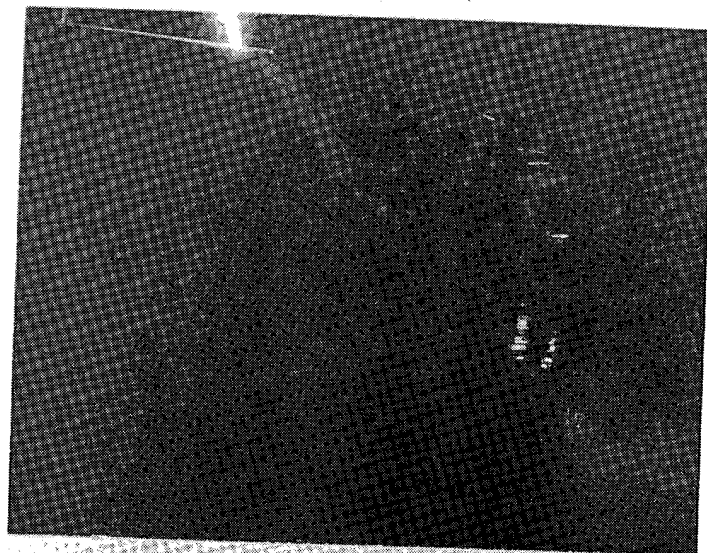
Photo XVI-3. Run XVI.  
Note arc path.

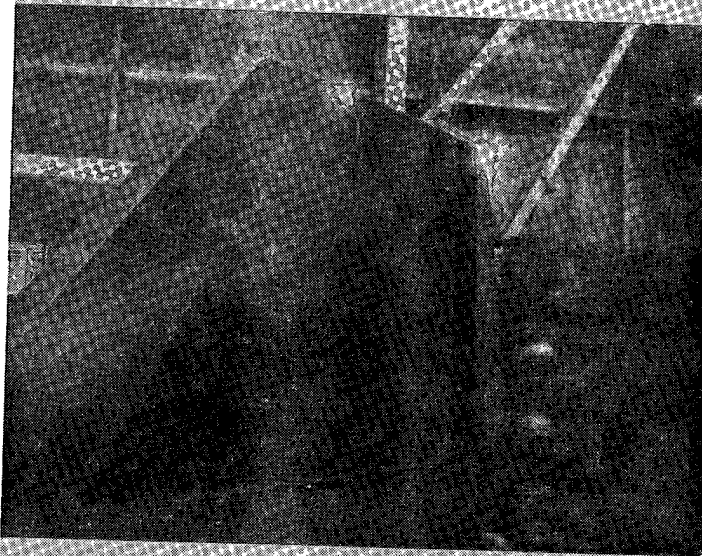
Photo 1-1. Run 1.  
Note emergence of  
arc at about 30 percent  
chord point on tip.  
Slight damage.

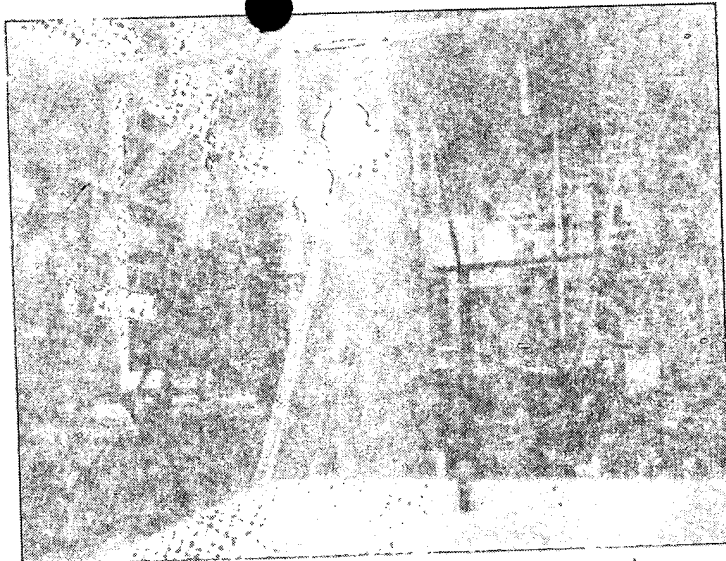
Photo 9-1. Run 9.  
L.E. tapes removed.

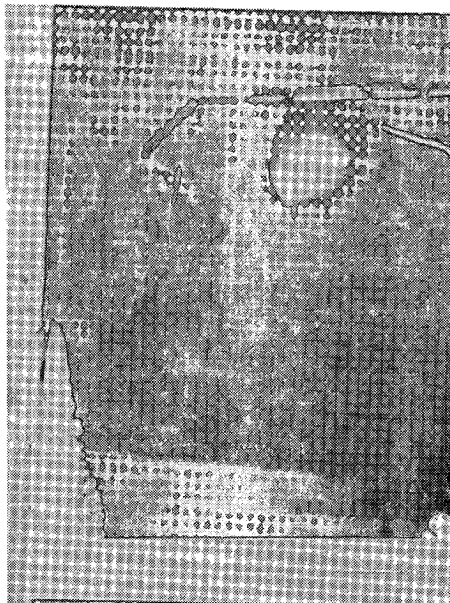
Photo 11-1. Run 11.  
Tape along top partially  
removed.

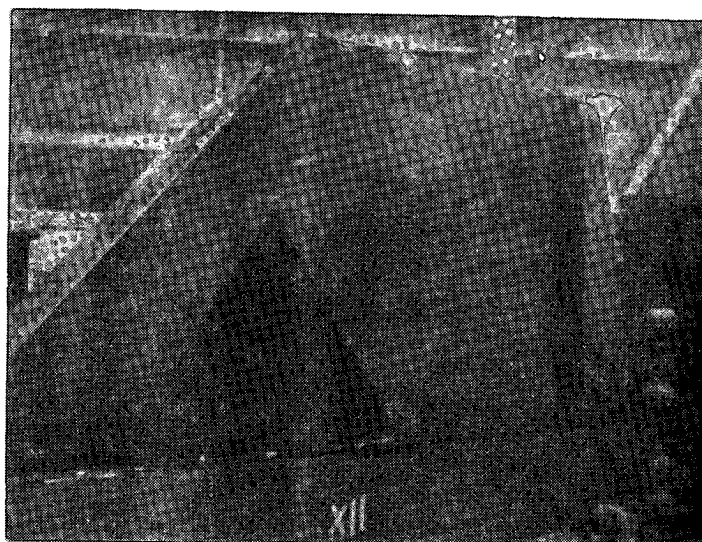
Photo 12-1. Run 12. See tapes removed.
